Rockdale Dam

Rockdale Millpond Restoration

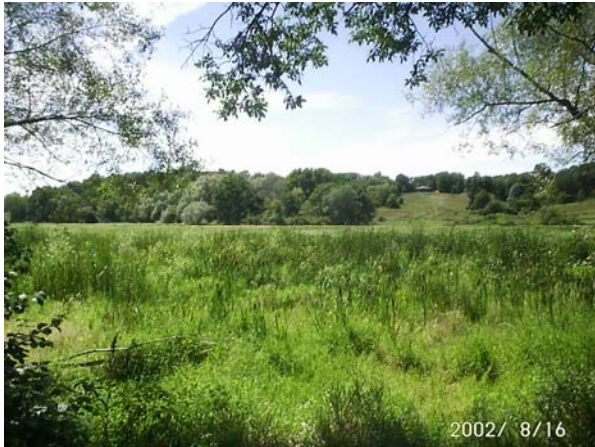
Southern view of lower historic millpond area.
Note: wetland species and habitat diversity.
Wetland species diversity will benefit waterfowl, amphibians and reptiles.

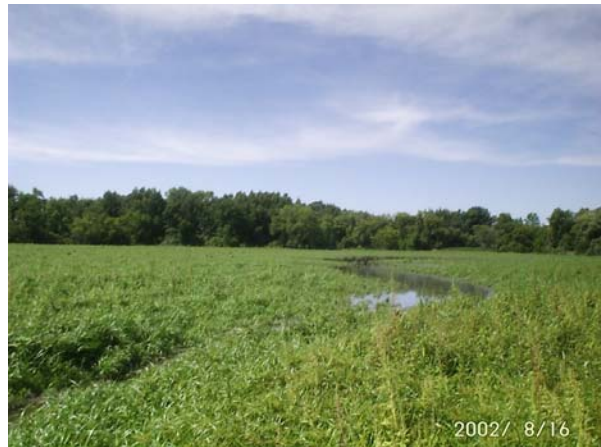
Northern view of restored spring channel.
Potential spawning and nursery habitat for northern pike.

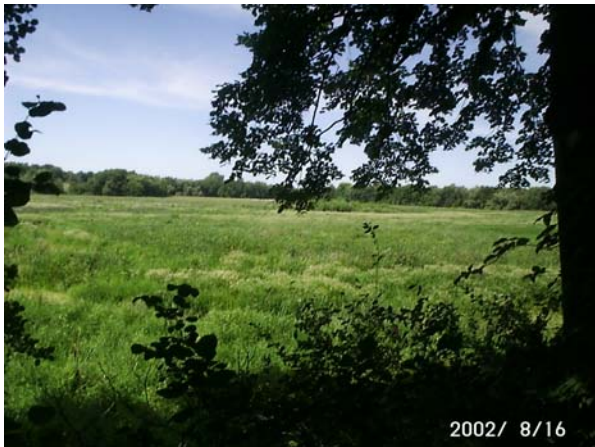
Shallow, warm-water carp habitat and thermal impacts eliminated.

By removing the dam and restoring the channel, the thermal impact and the fish barrier were eliminated. Anecdotal information from area anglers indicated that the carp dominance no longer exists and sportfish populate the area. Fisheries surveys are planned for this year to confirm this information. Wetland diversity was enhanced benefiting waterfowl, amphibians and reptiles. County staff and friends groups have continued to remove invasive species and to improve the habitat.

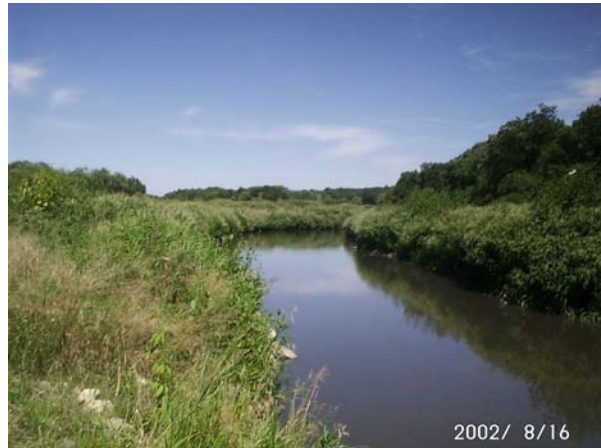
Restored riverine channel through historic millpond allowing fish migration to upper reaches of Koshkonong Creek

There were three phases of channel restoration. The lower impoundment channel banks were regraded to provide an annual floodplain and to stabilize the banks. The channel's head cut stalled and we had to mechanically cut the channel sediments to continue to establish the new channel. Staff and neighbors probed the millpond sediments and located the original channel. The third phase include reestablishing the upper channel in the lower pool into the 'narrows'. All together approximately 9,800 feet of channel was reestablished upstream of the dam site through the former millpond.
